Story Road Mitigation Site No. 1

Environmental Mitigation Monitoring Year 5 (2008) Monitoring Report

STORY ROAD MITIGATION SITE No. 1

ENVIRONMENTAL MITIGATION MONITORING REPORT

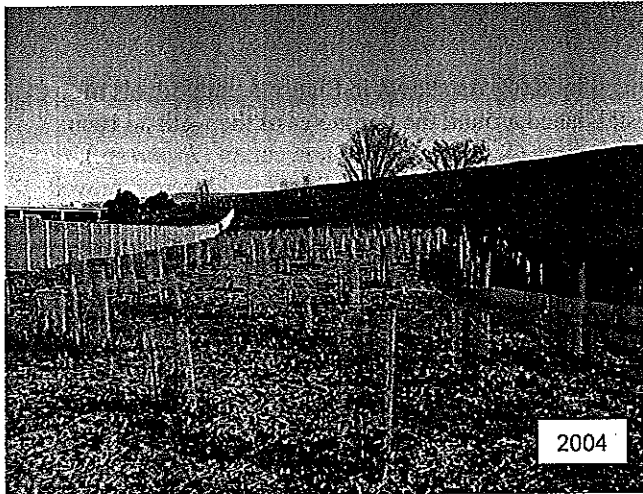
Figure 3. View of riparian planting area at northern edge of mitigation area, January 2004. (Photo station #1)

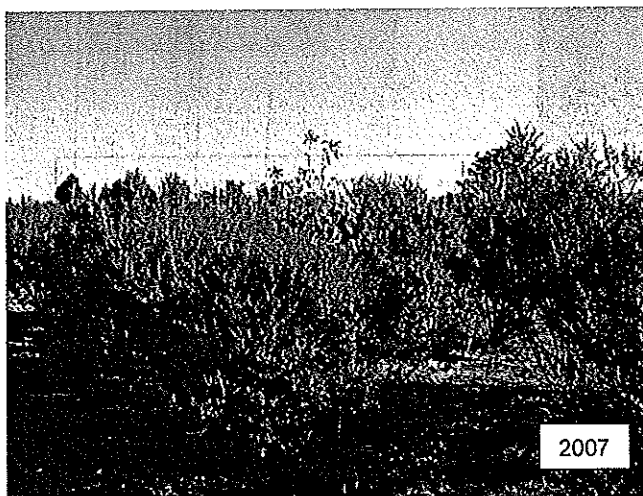
Figure 4. View of riparian planting area at northern edge of mitigation area, September 2008. (Photo station #1)

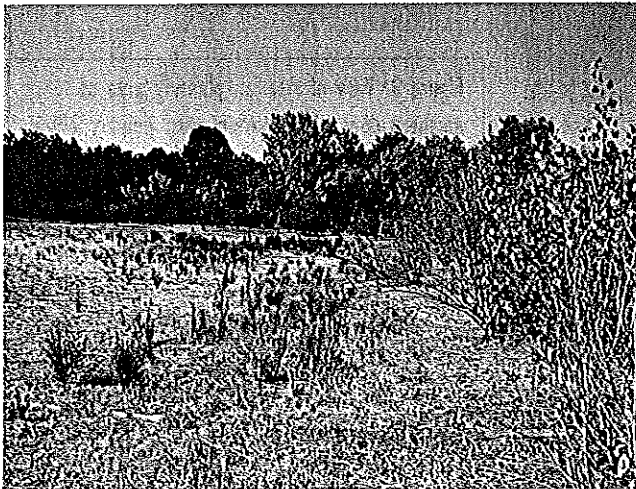
Natural recruitment of native plant species continued in 2008. As shown in Figure 5, individuals of Fremont cottonwood (*Populus fremontii*), have established around the perimeter of the wetland basin. Other naturally occurring native species are arroyo willow (*Salix lasiolepis*) and cattail (*Typha* sp.). In November and early December the above-ground irrigation lines and sprinkler heads were removed from the planting area and stockpiles for removal by City crews. The irrigation controllers will remain on site. The perimeter fence and gates will be retained until 2012 (or longer if so desired by the City).

Figure 5. View of volunteer cottonwoods growing at the basin edge, September 2008.

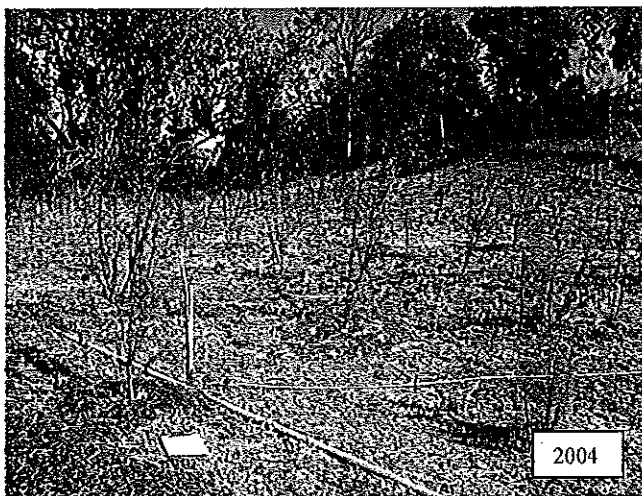
Figure 8. View of Sample Plot 1, September 2004. Sample plot contains 13 plants (all alive). Herbaceous cover is 80%; shrub cover is 20% and tree cover is 0%.

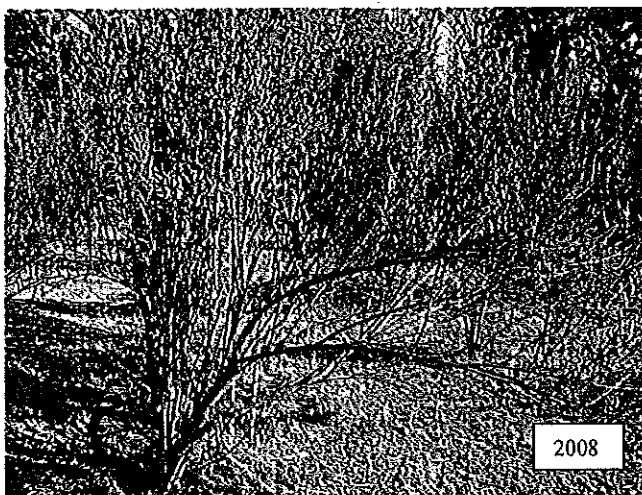
Figure 8B. View of Sample Plot 1, September 2008. Herbaceous cover is 35%; shrub cover is 60% and tree cover is 5%.

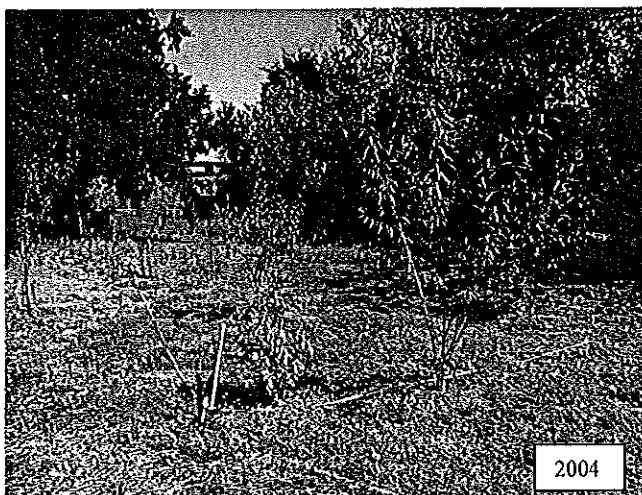
Figure 9A. View of Sample Plot 2, September 2004. Sample plot contains 10 plantings (all alive). Herbaceous cover is 65%; shrub cover is 25% and tree cover is 10%.

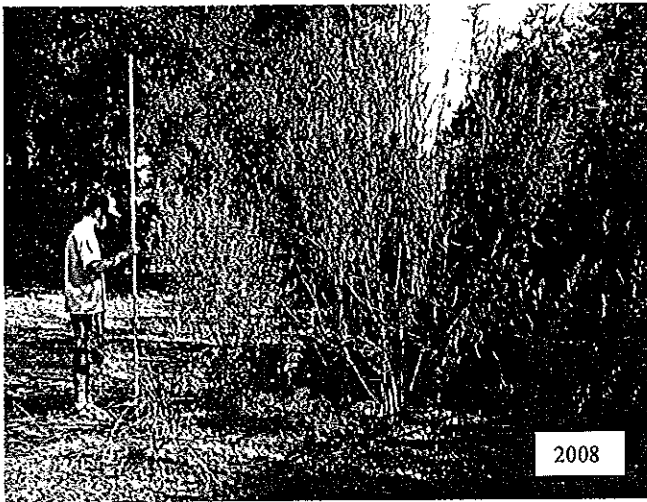
Figure 9B. View of Sample Plot 2, September 2008. Herbaceous cover is 30%; shrub cover is 60% and tree cover is 10%.

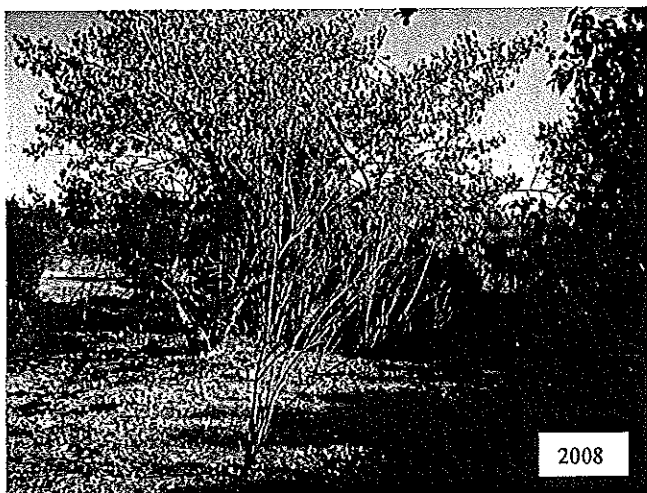
Figure 10B. View of Sample Plot 3, September 2008. Herbaceous cover is 10%; shrub cover is 40% and tree cover is 50%.

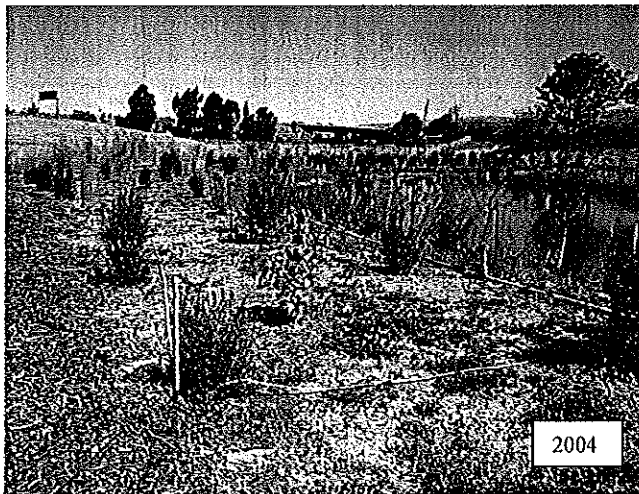
Figure 11A. View of Sample Plot 4, September 2004. Sample plot contains 13 plantings (11 alive, 1 dead). Herbaceous cover is 54%; shrub cover is 25% and tree cover is 1%.

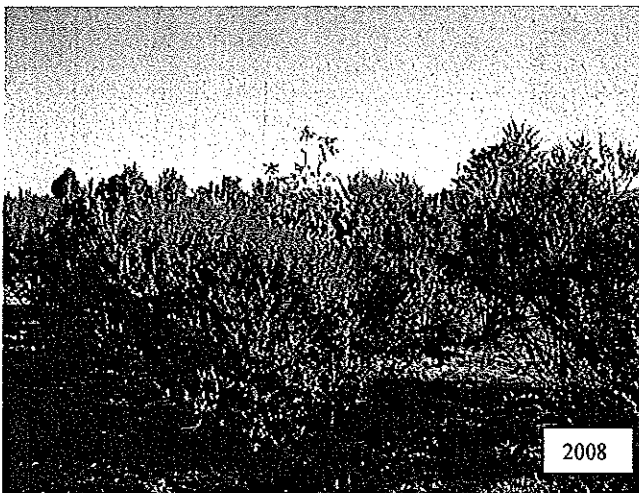
Figure 11B. View of Sample Plot 4, September 2008. Herbaceous cover is 10%; shrub cover is 80% and tree cover is 10%.

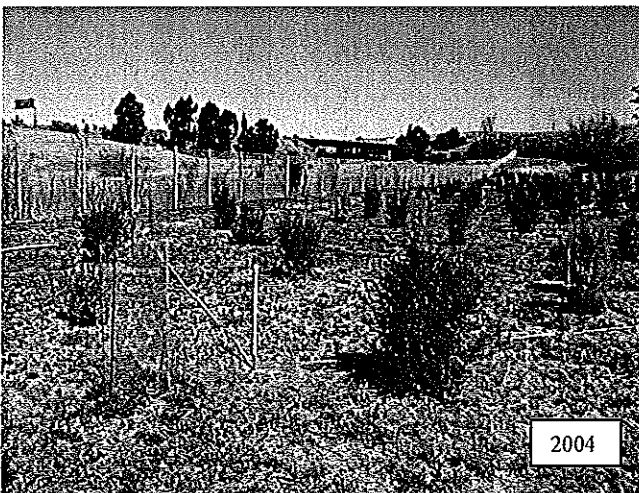
Figure 12A. View of Sample Plot 5, September 2004. Sample plot contains 11 plantings (10 alive, 1 dead). Herbaceous cover is 65%; shrub cover is 30% and tree cover is 2%.

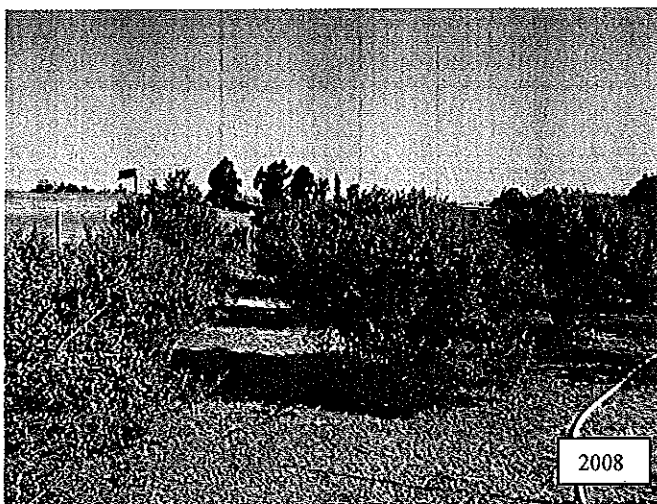
Figure 12B. View of Sample Plot 5, September 2008. Herbaceous cover is 45%; shrub cover is 50% and tree cover is 5%.

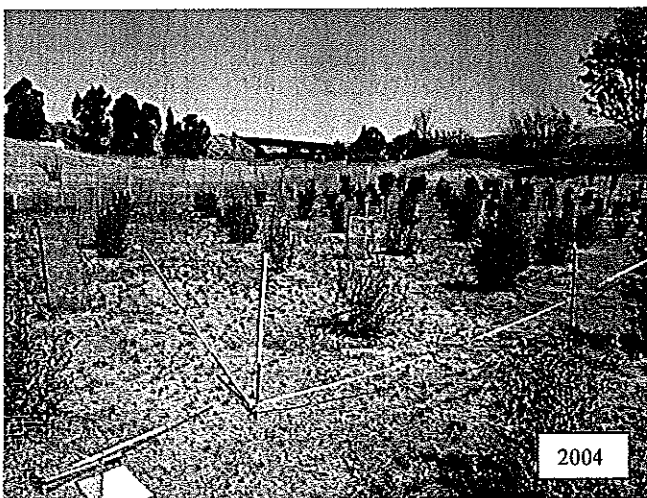
Figure 13A. View of Sample Plot 6, September 2004. Sample plot contains 10 plantings (all alive). Herbaceous cover is 65%; shrub cover is 30%, tree cover is 0% and bare ground is 5%.

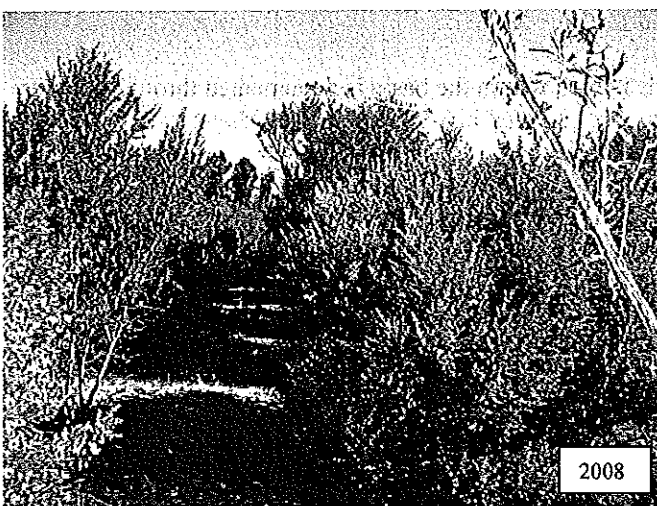
Figure 13B. View of Sample Plot 6, September 2008. Herbaceous cover is 20%; shrub cover is 70%, tree cover is 10%.

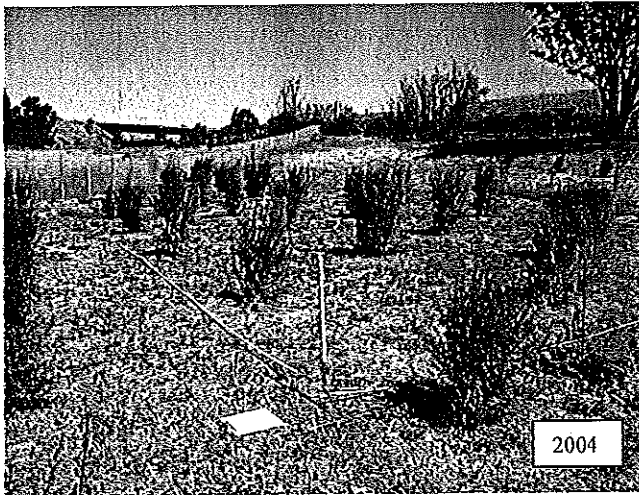
Figure 14A. View of Sample Plot 7, September 2004. Sample plot contains 9 plantings (all alive). Herbaceous cover is 50%; shrub cover is 45%, tree cover is 0% and bare ground is 5%.

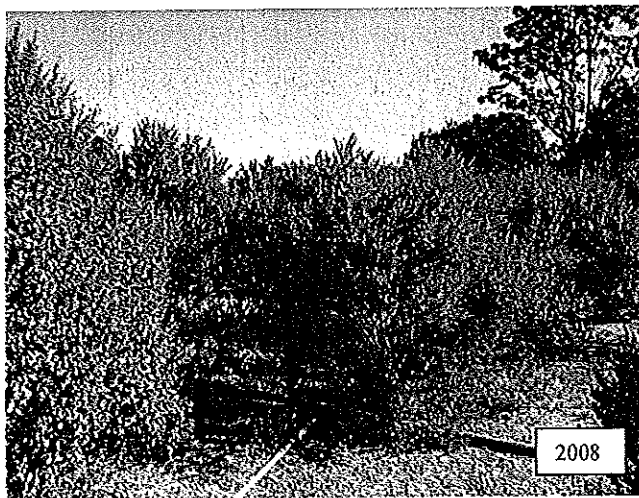
Figure 14B. View of Sample Plot 7, September 2008. Herbaceous cover is 20%; shrub cover is 70%, tree cover is 10%.

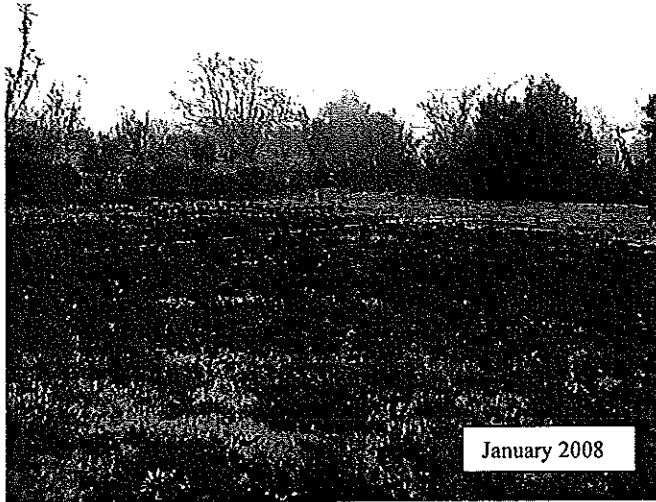
Figure 15. View of wetland basin, which was dry in early January. Rainfall filled basin later in winter season, but the basin went dry earlier than normal due to drought conditions.

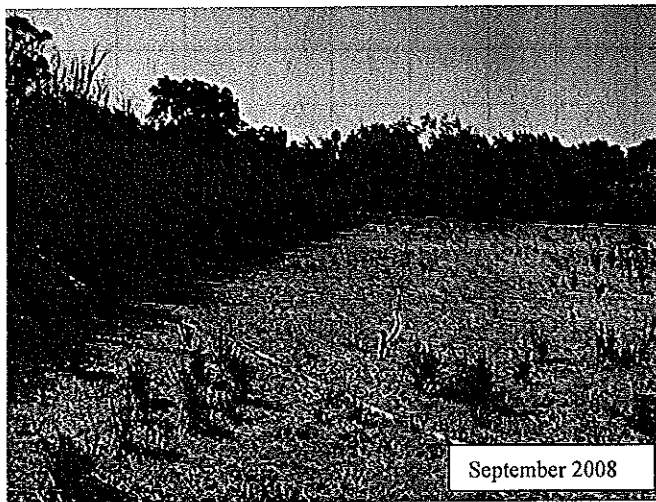
Figure 16. View of wetland basin in September 2008. Note young coyote brush plants establishing in the basin, likely due to 2nd consecutive year of drought conditions.
